# Flightfax<sup>®</sup>

## Online Report of Army Aircraft Mishaps

# Mishap Review: CH-47F NVG Extraction

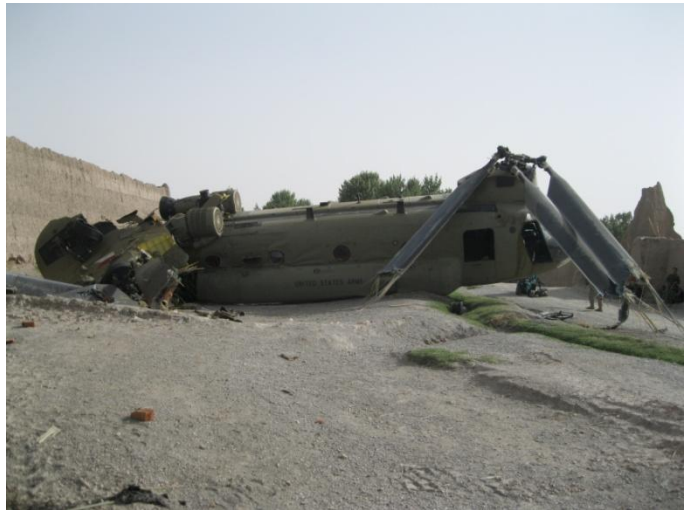
**While conducting a two-ship NVG approach to extract ground forces, chalk 2 impacted the ground approximately 1 NM short of the PZ, heavily damaging the right side of the aircraft and shearing the aft pylon. The crew received minor injuries.**

The accident board determined that while conducting a hasty air assault at night in low illumination conditions, the crew of the CH-47F, in trail position of a flight of two, failed to maintain a proper scan. The PC and AMC/PI became fixated on lead and actions in the vicinity of the PZ and maneuvered the aircraft into an unperceived OGE hover condition at a low power setting with an excessive upwards pitch. The aircraft descended rapidly, impacting aft first with a significant right roll. The impact caused minor injuries to the crew and separated the aft pylon from the aircraft.
